<b>WINNEBAGO</b>		COPYRIGHT 2006 WINNEBAGO INDUSTRIES, INC.	
DFTR	ORIG. DATE		
CHKR	ALL DIMENSIONS ARE IN MILLIMETERS		
P.E.	FIRST USED	09 D29R	
M.E.			
DSNR			
UNSPECIFIED TOLERANCES ARE:		MATERIAL:	
WHOLE DIM (X)	:		
ONE-PLACE (X.X)	:		
TWO-PLACE (X.XX)	:		
ANGLE	:		
THIRD ANGLE PROJECTION			
DO NOT SCALE DRAWING			
TITLE: WIRING DIAGRAM-BODY, 110V			
SHEET 1 OF 1	PART NO	166182	REV
REF:	1 11/1/2007

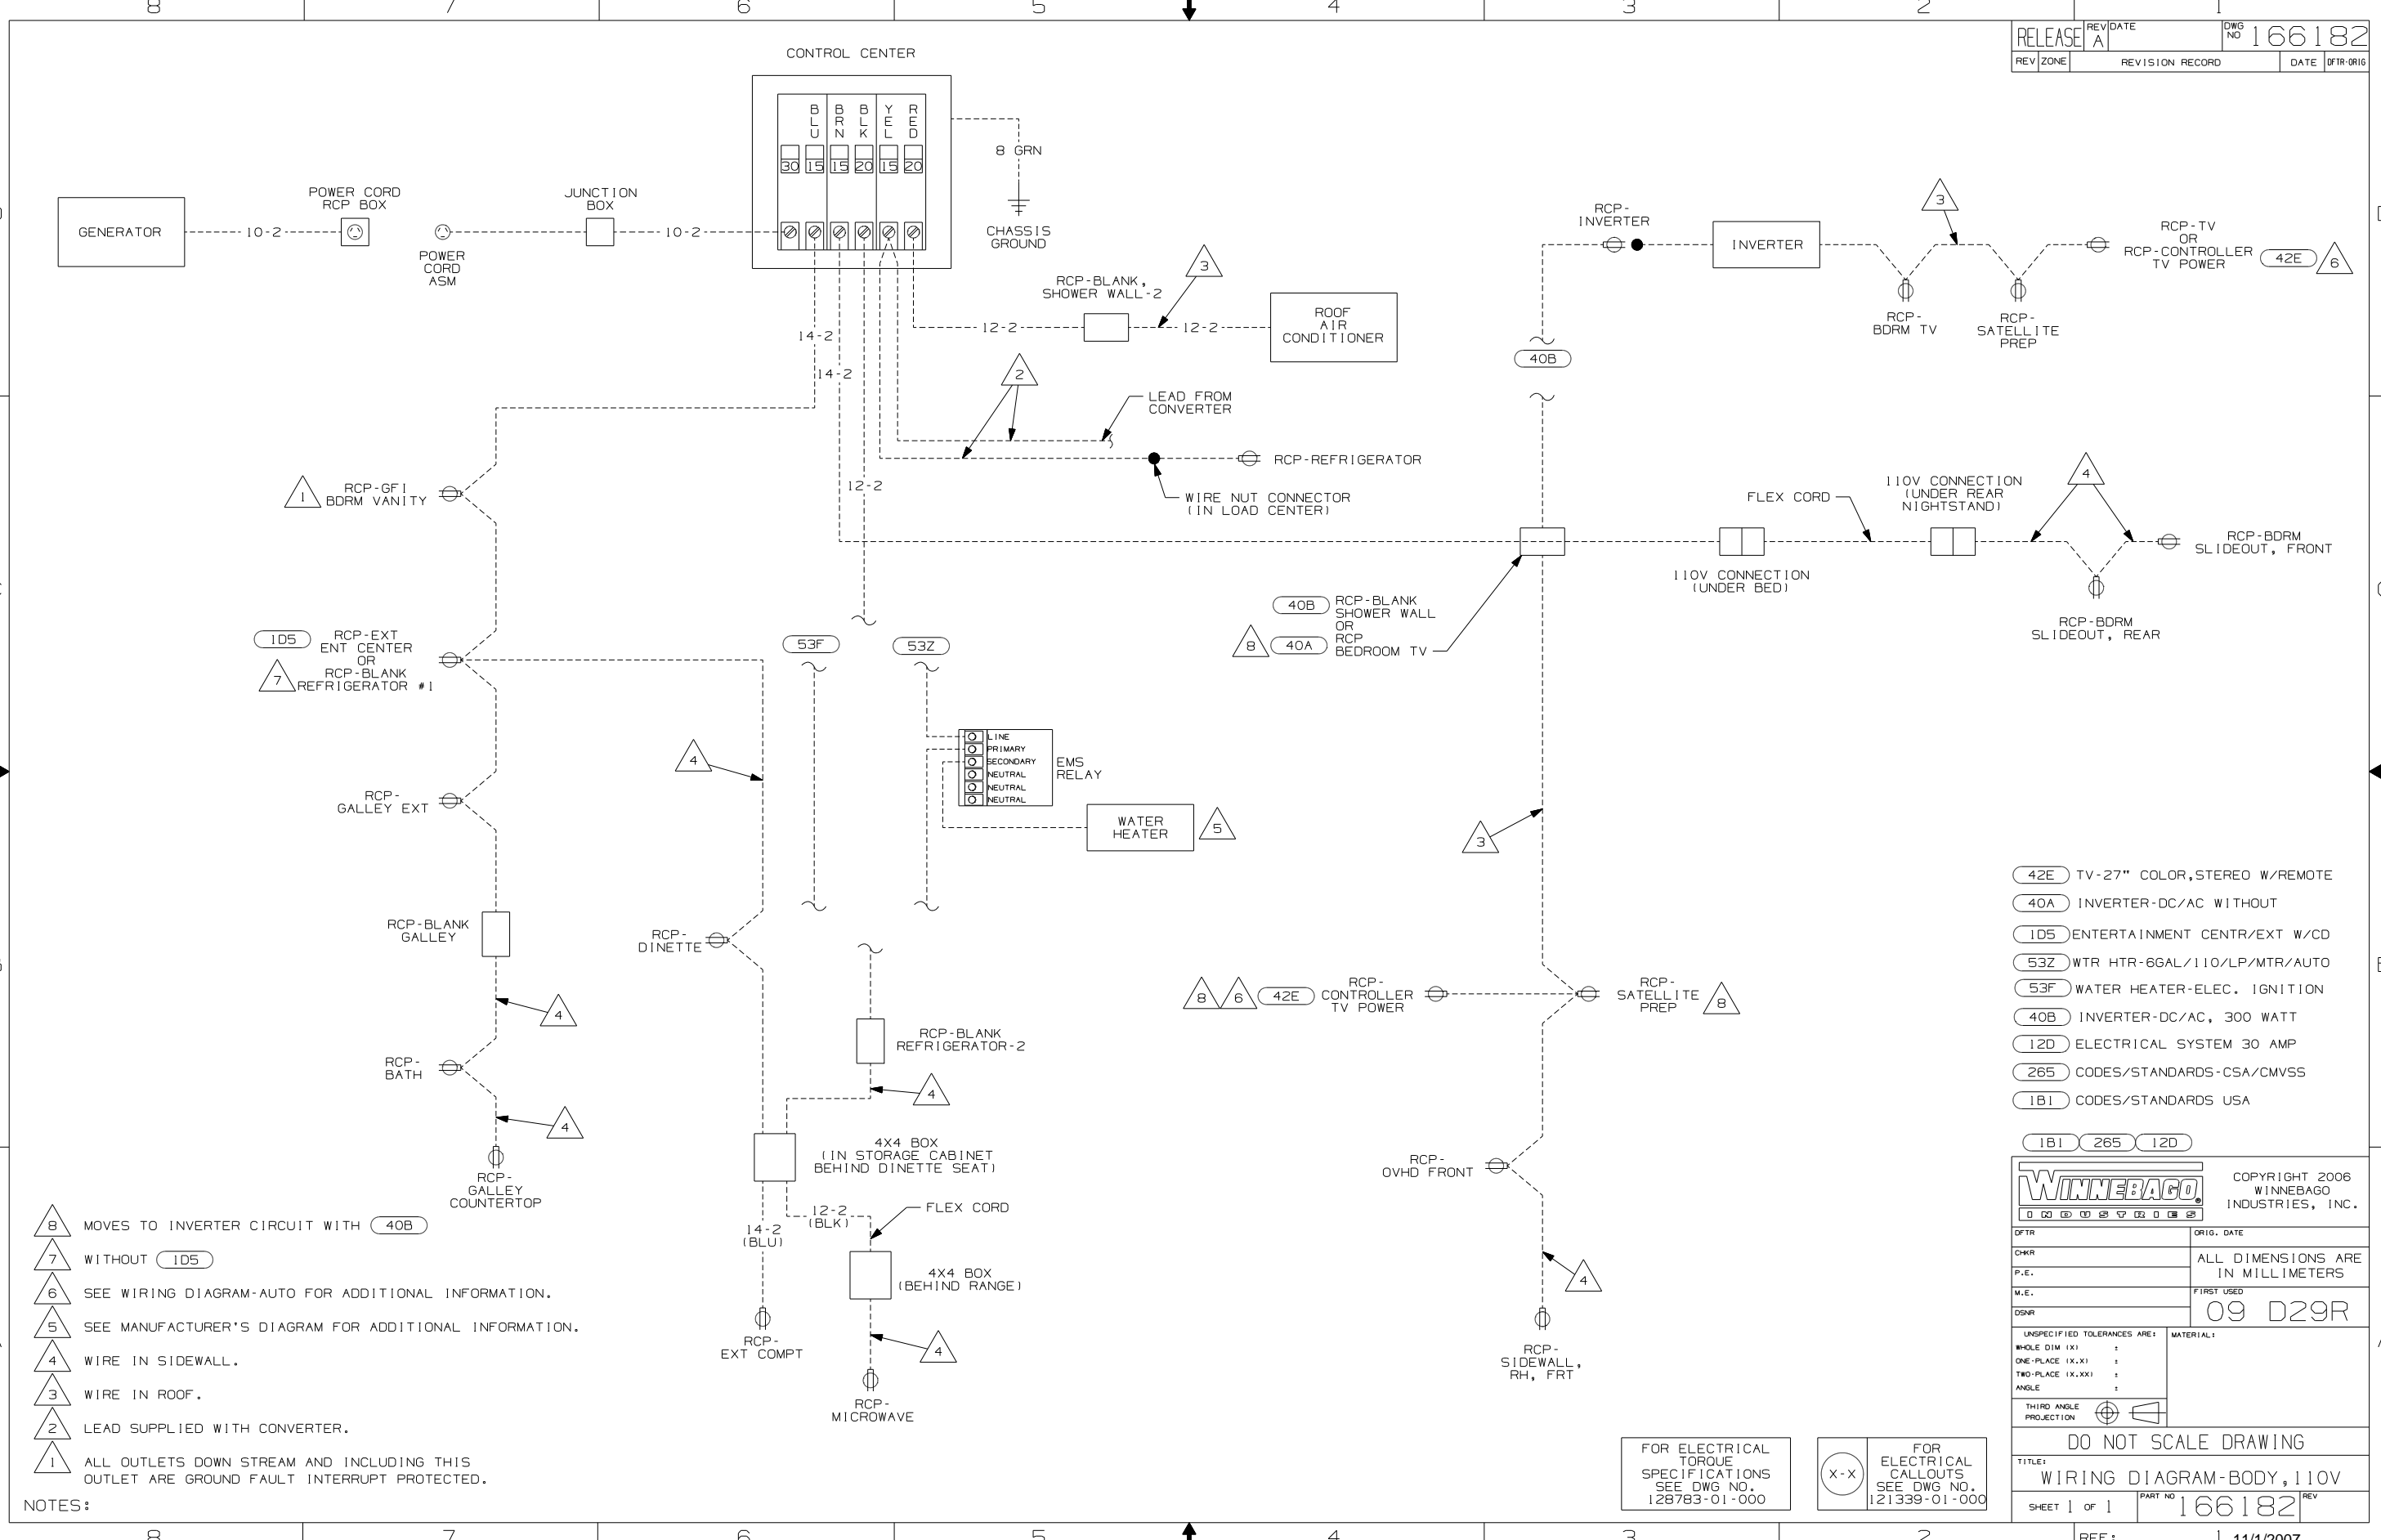
- NOTES:
- 8 MOVES TO INVERTER CIRCUIT WITH 40B
  - 7 WITHOUT 1D5
  - 6 SEE WIRING DIAGRAM-AUTO FOR ADDITIONAL INFORMATION.
  - 5 SEE MANUFACTURER'S DIAGRAM FOR ADDITIONAL INFORMATION.
  - 4 WIRE IN SIDEWALL.
  - 3 WIRE IN ROOF.
  - 2 LEAD SUPPLIED WITH CONVERTER.
  - 1 ALL OUTLETS DOWN STREAM AND INCLUDING THIS OUTLET ARE GROUND FAULT INTERRUPT PROTECTED.
